# **Vulnerability of Electric Power Systems to Volcanic Ashfall Hazards**

**Doctor of Philosophy in Hazard and Disaster  
Management**

**John Blackburn Wardman**

**2013**

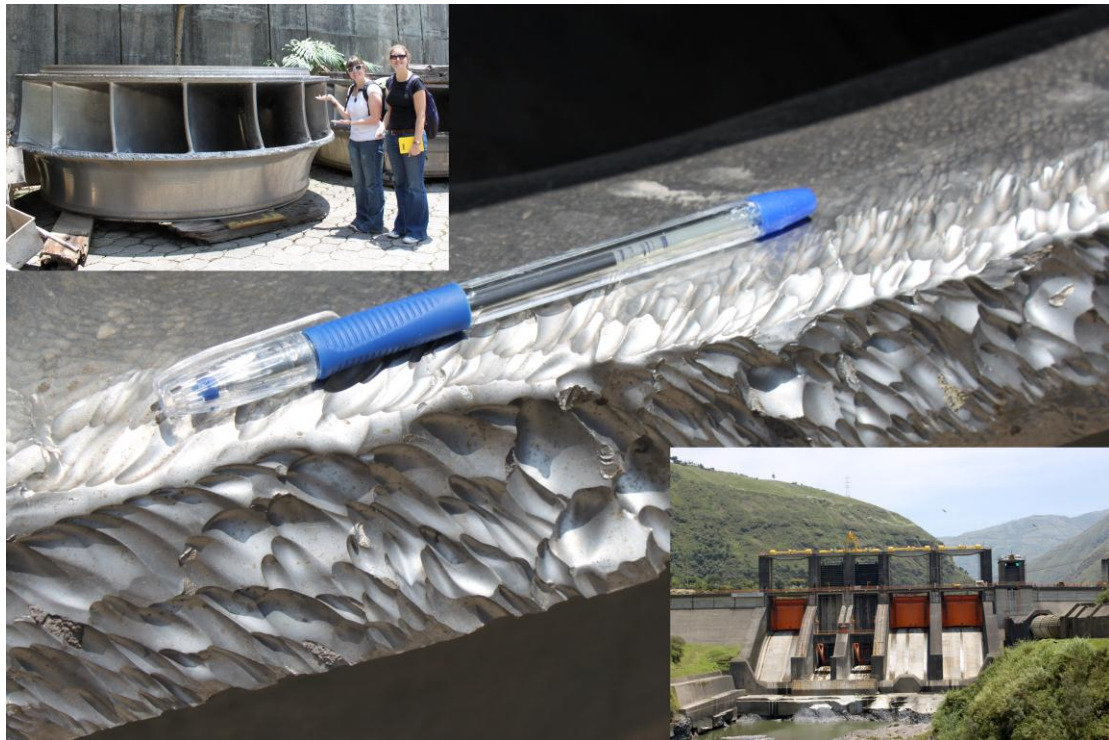
**Figure 2.2:** A severely abraded turbine that was removed from service at the Agoyan hydroelectric power plant, which is sited 5 km east of Baños. Ash-laden water filtering through the turbines has necessitated the replacement of 4 turbines in 21 years. Bottom inset: The Agoyan Dam and its (orange) floodgates are designed to let highly turbid water bypass the turbines so as to avoid accelerated wear of generation components.

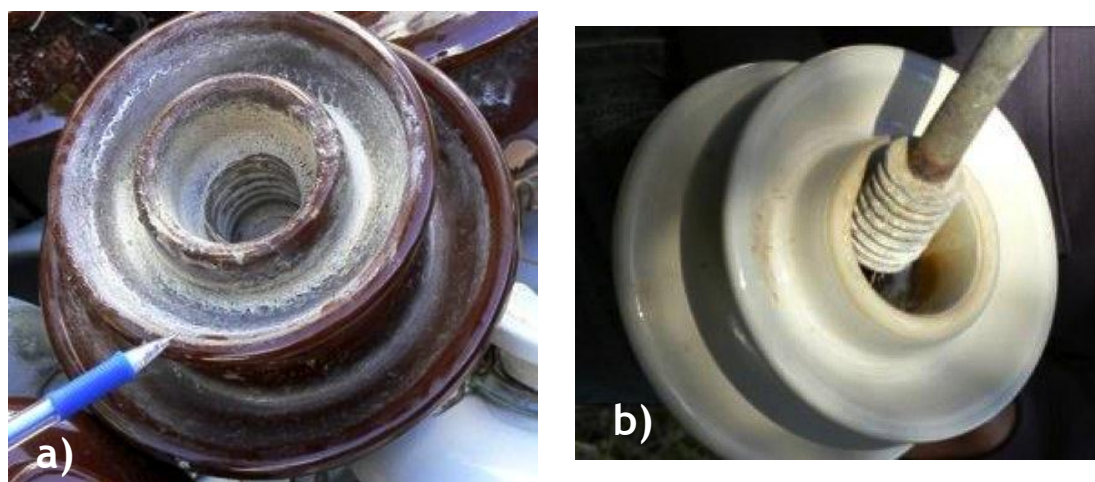
**Figure 2.3:** a) Fine grained ash adhered to the underside of a 33 kV porcelain insulator in Futaleufu, Chile following the 2008 Chaitén eruption. b) Underside of a 33 kV porcelain insulator that suffered ash-induced flashover following the 2008 Chaitén eruption. Note the brown burn mark (centre-right) from the high intensity arc during flashover.

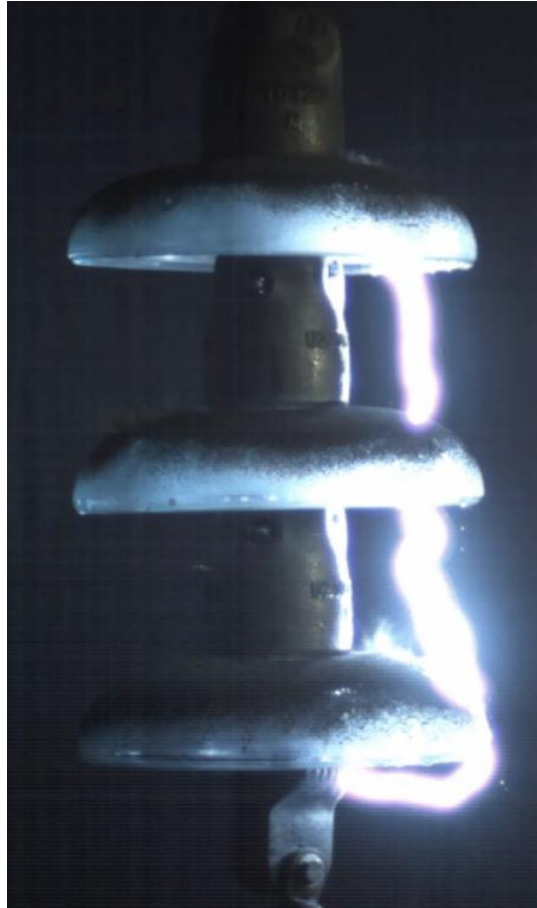
**Figure 3.1:** Insulator flashover across three glass ‘fog-type’ units (sheds) contaminated with ~2 mm of wet ash. Photo taken in the University of Canterbury HV laboratory.

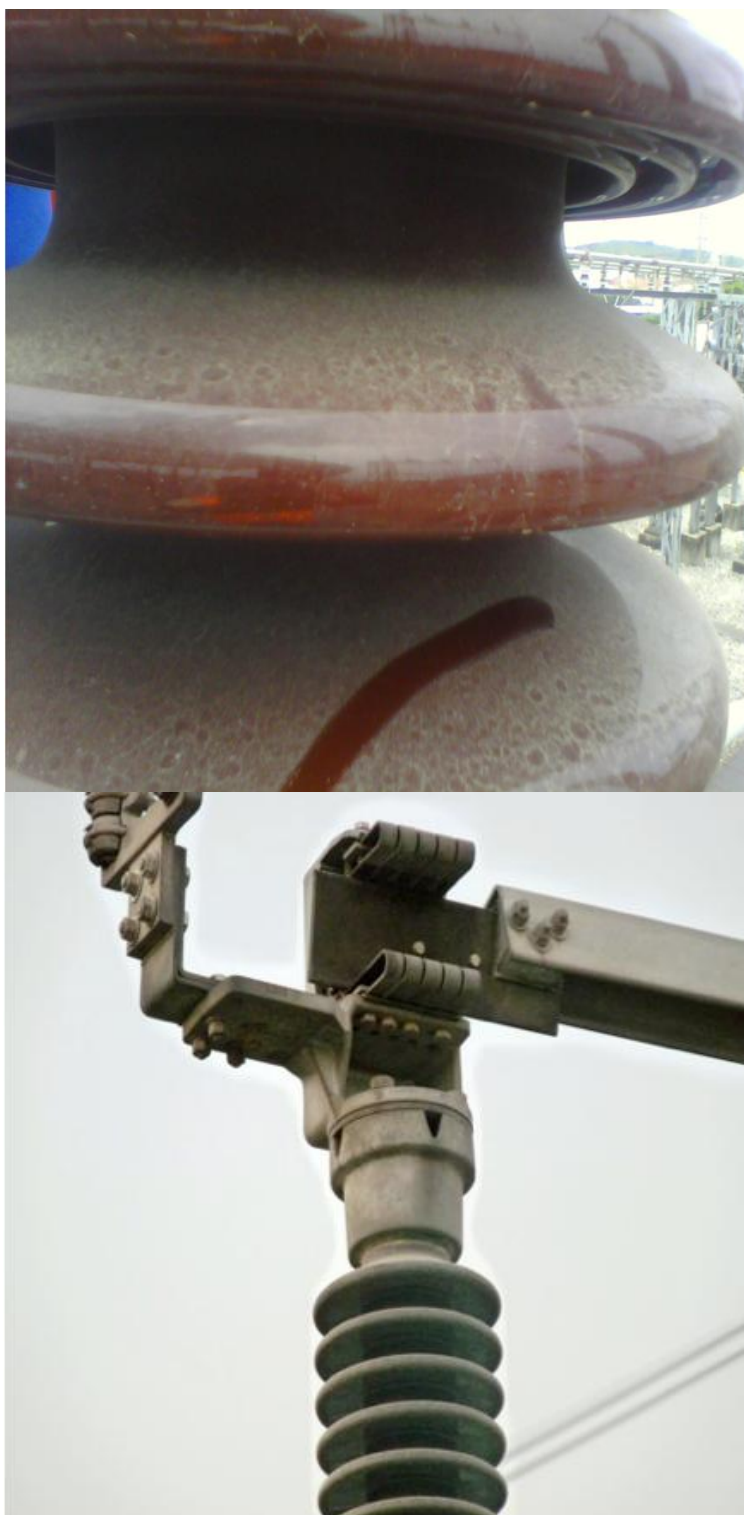
Figure 13 Above: 138 kV transformer bushing coated in 1-2 mm of fine-grained ash at a Guayaquil substation. Below: a contaminated disconnect switch. (Photos Courtesy of Transelectric, Ecuador).

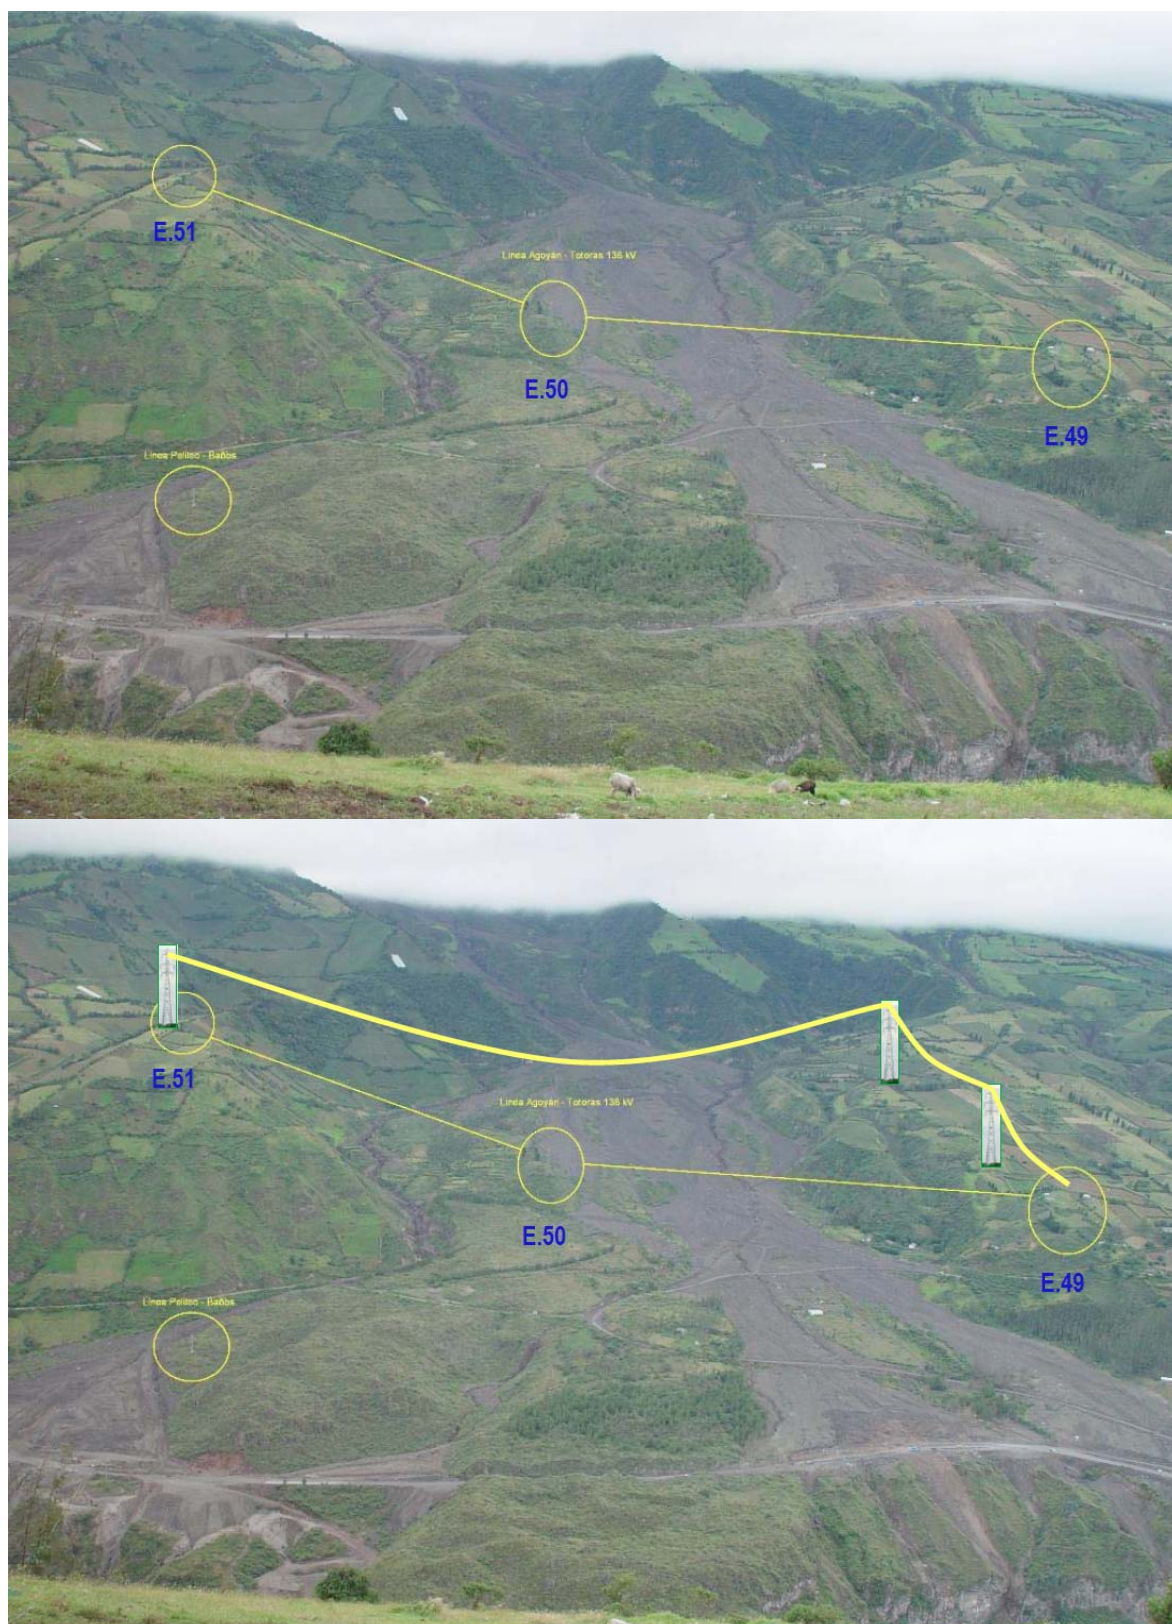
Figure 14 Above: 138 kV transmission tower (E50) situated in a 2006 lahar path. Below: Proposed re-design of the 138 kV transmission circuit showing relocation of towers and conductors (lines) to avoid lahars (Photo's courtesy of Transelectric, Ecuador).

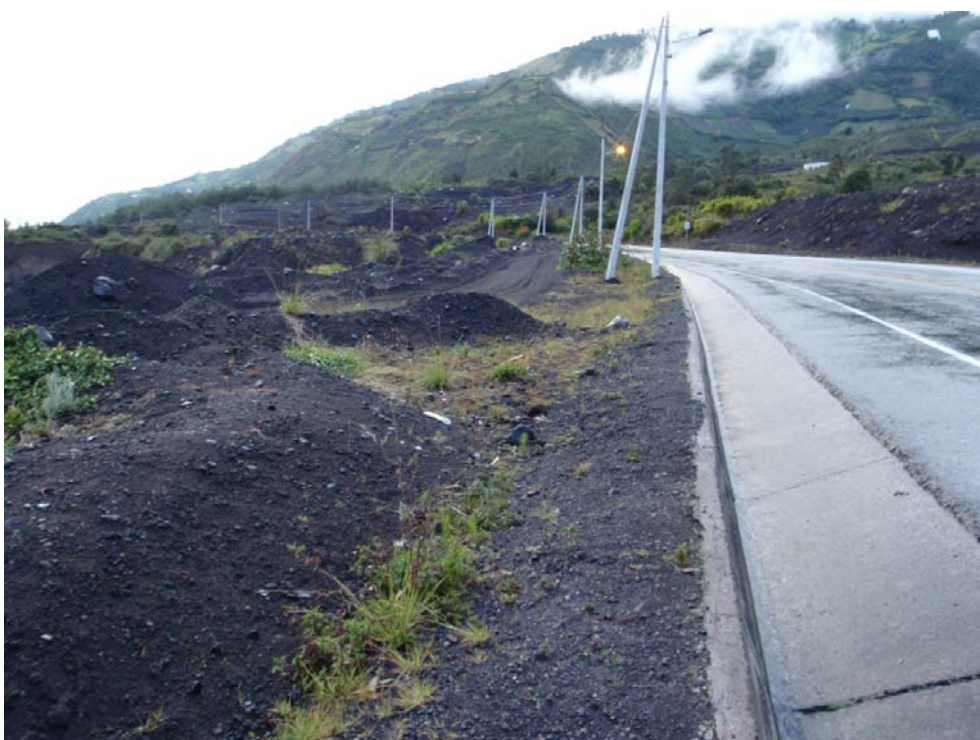
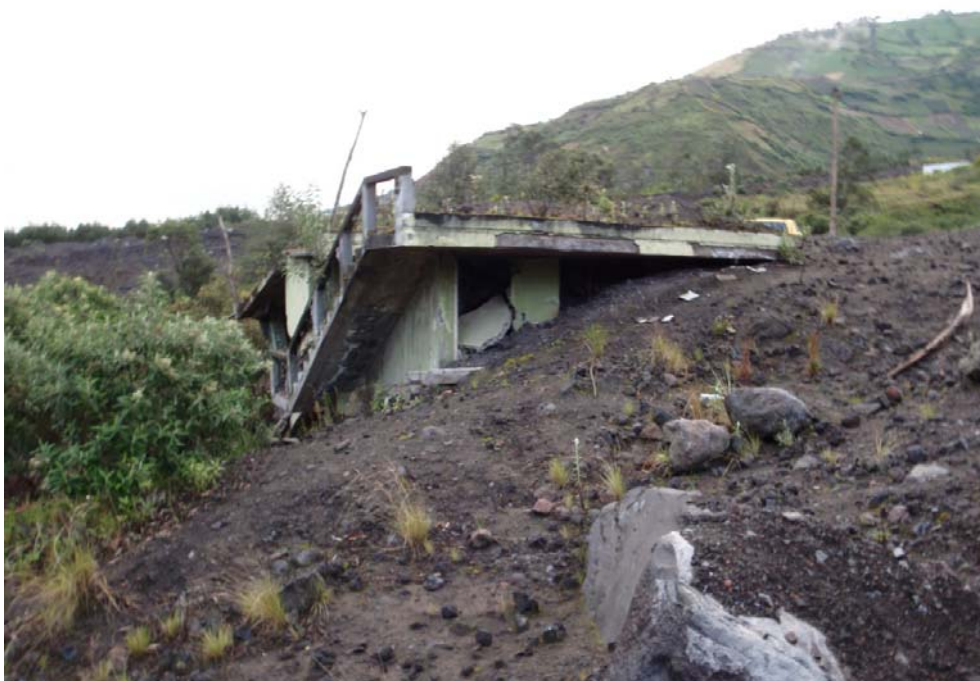
Figure 15 Area of lahar damage in Juive Chico, west of Baños (GPS 16). Upper photo: new section of road replacing lahar-damaged section. Lower photo: in same area, house buried by lahar deposits.

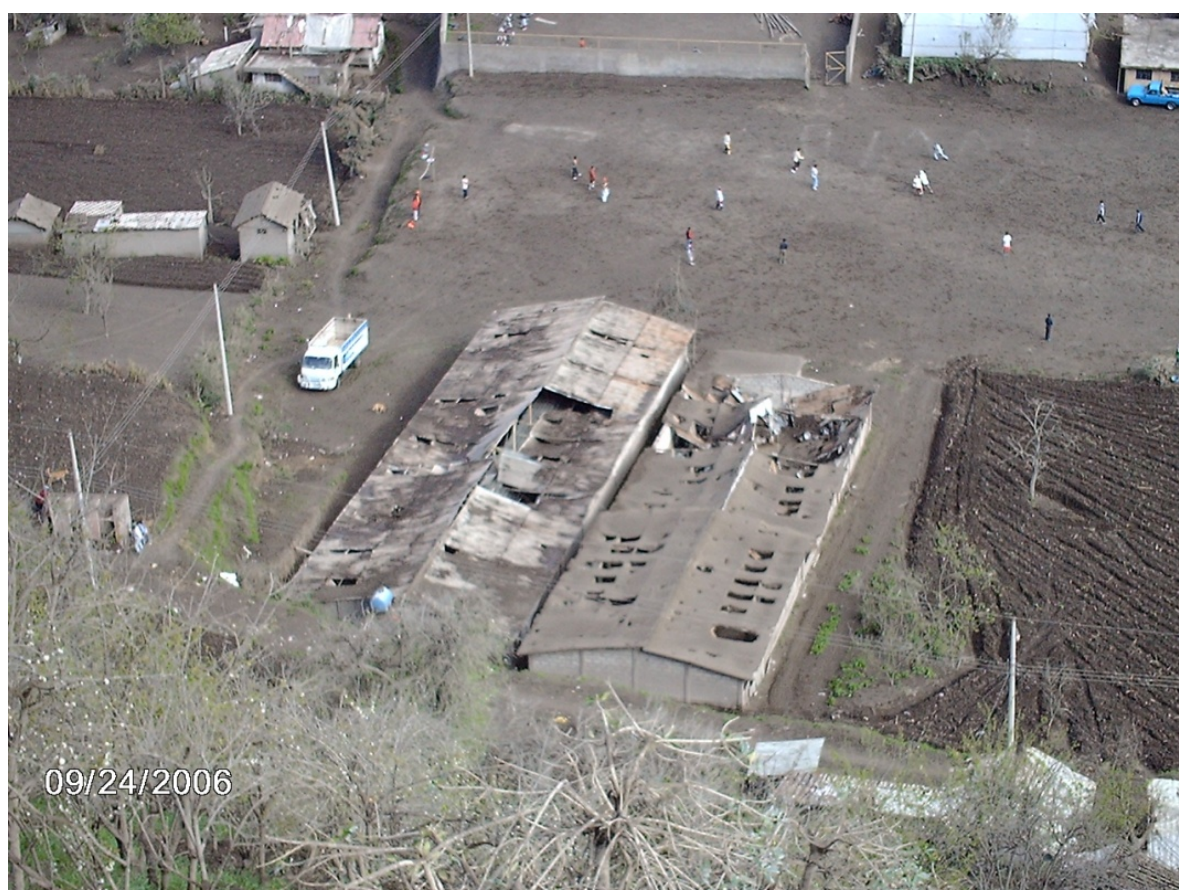
Figure 19 Ballistic block damage to shed roof, Cotaló, 2006 (photo courtesy of Carlos Fernando Perez).

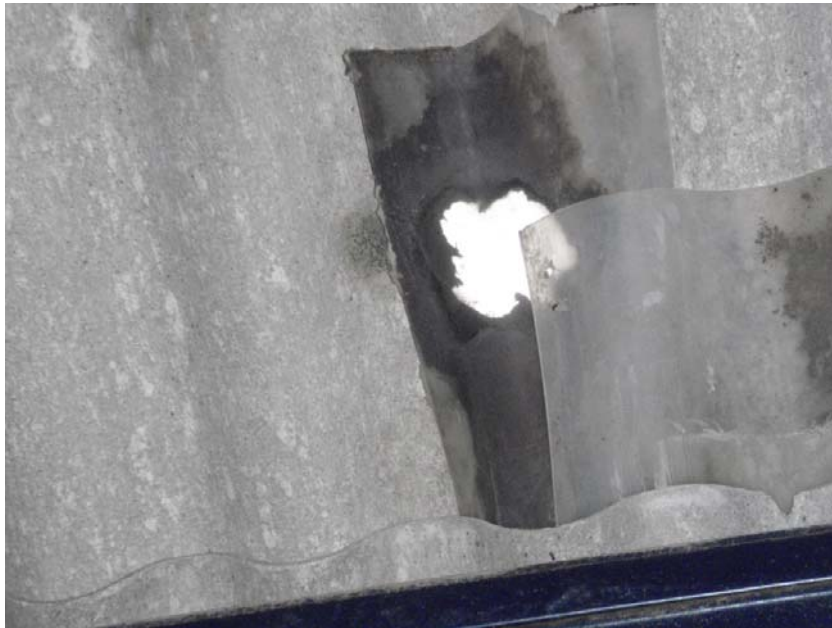
Figure 22 Ballistic damage to the roof of a chicken shed.

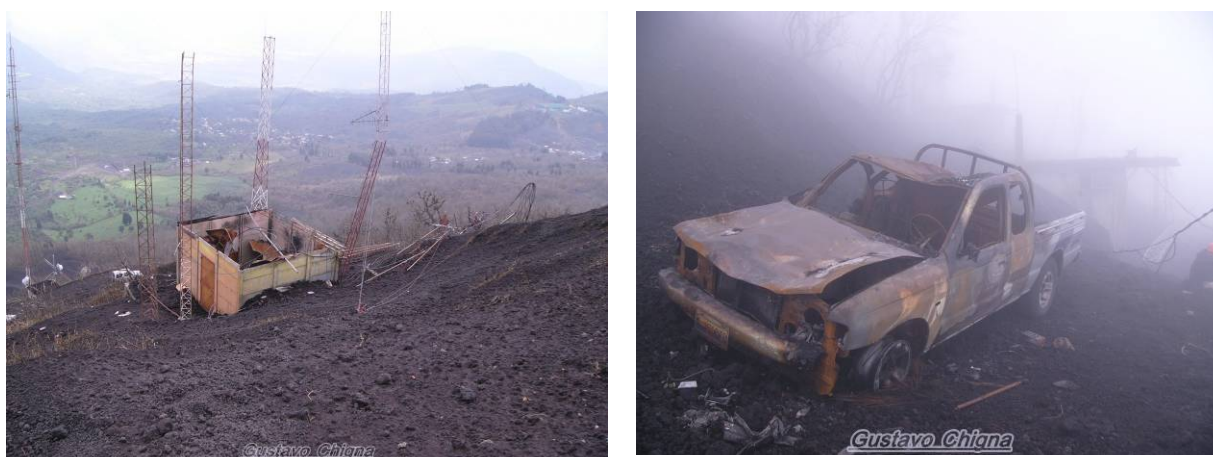
**Figure 2.10** Ballistic clast damage to radio masts, building and vehicle in vicinity of Cerro Chino (photos: Gustavo Chigna, INSIVUMEH).

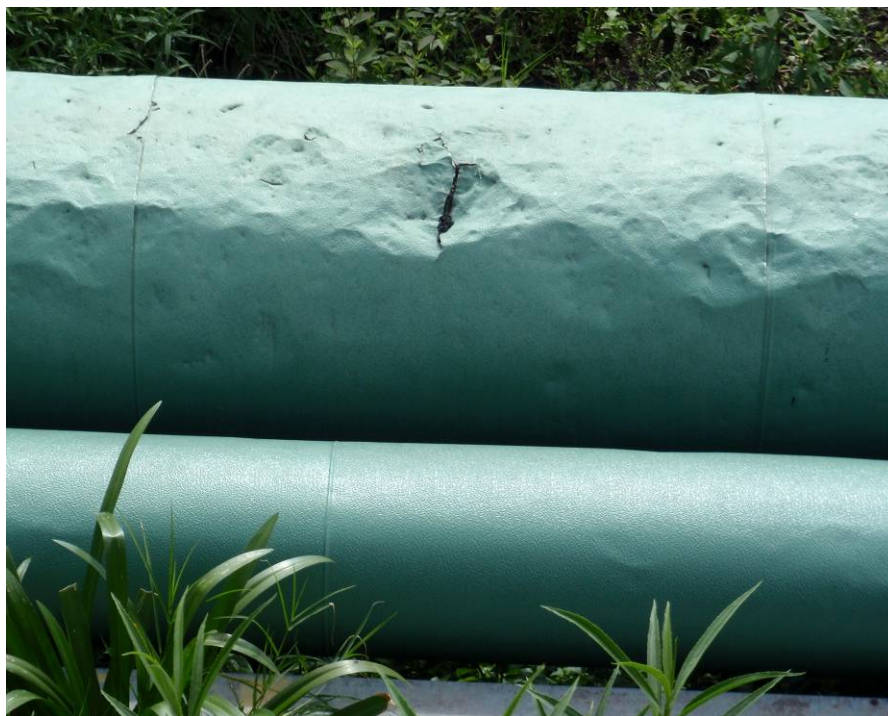
**Figure 3.2** Superficially damaged pipe cladding at the Amatitlán geothermal power plant (dent is approximately 20 cm wide).

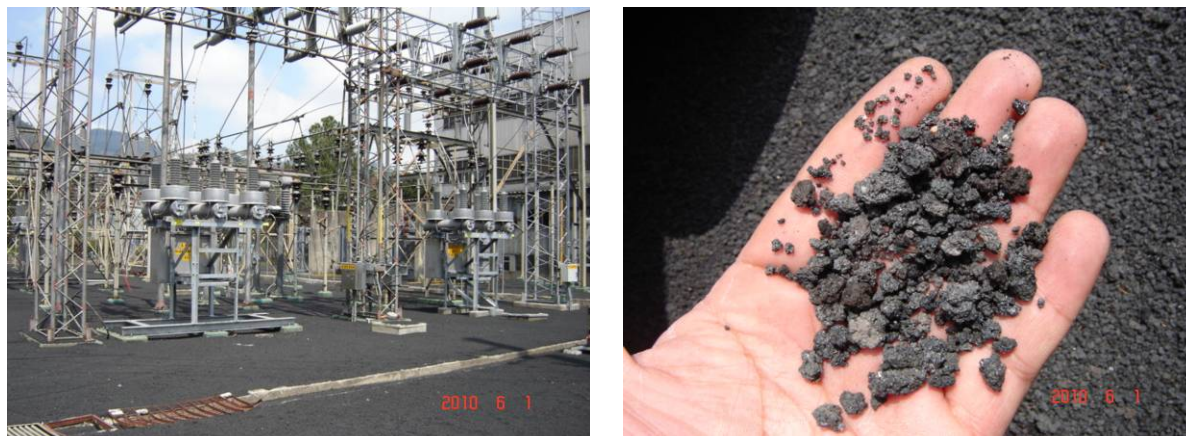
**Figure 3.4** Coarse tephra deposited at Laguna substation (see Figure 3.5 for location)(photos: EEGSA)

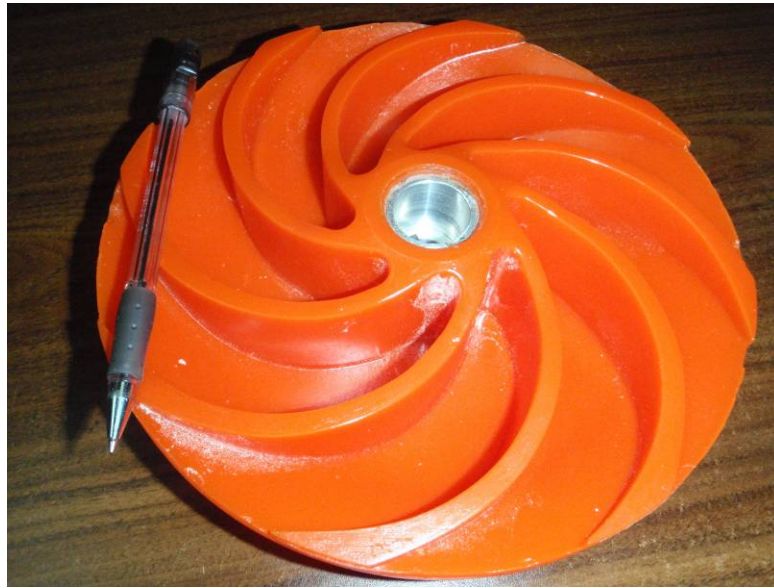
**Figure 3.7** Sludge pump propeller of the same type that suffered severe abrasional damage from volcanic tephra.

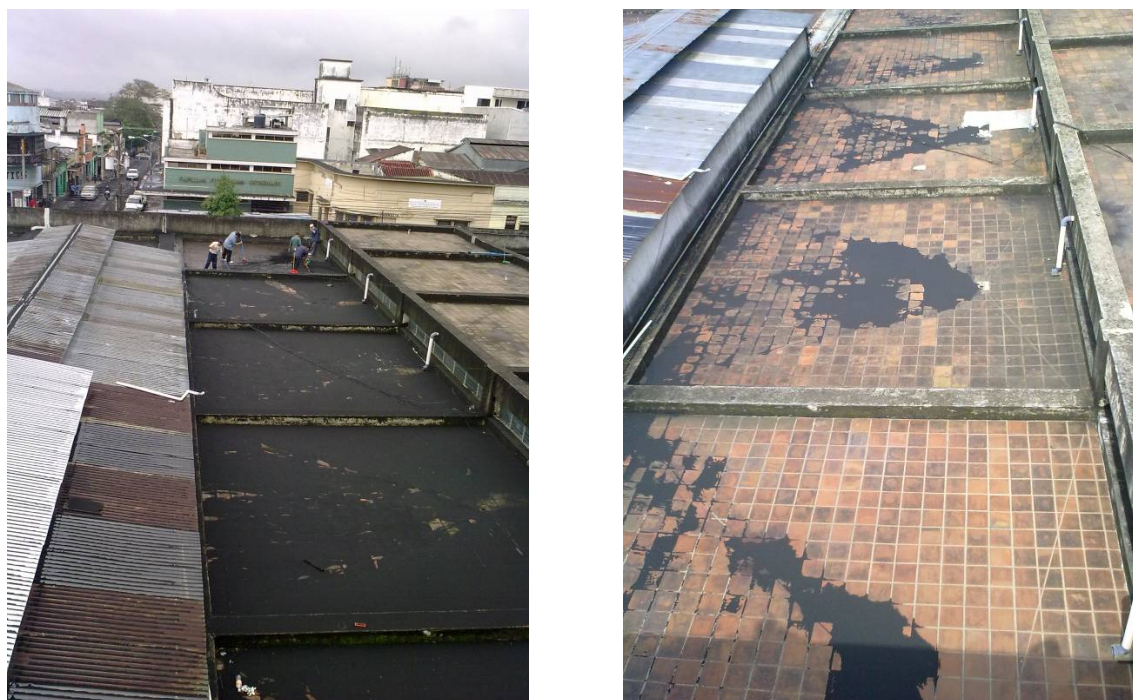
**Figure 3.11** Cleanup of tephra from roof in progress (left), and abrasion damage to surface coating on roof (right).

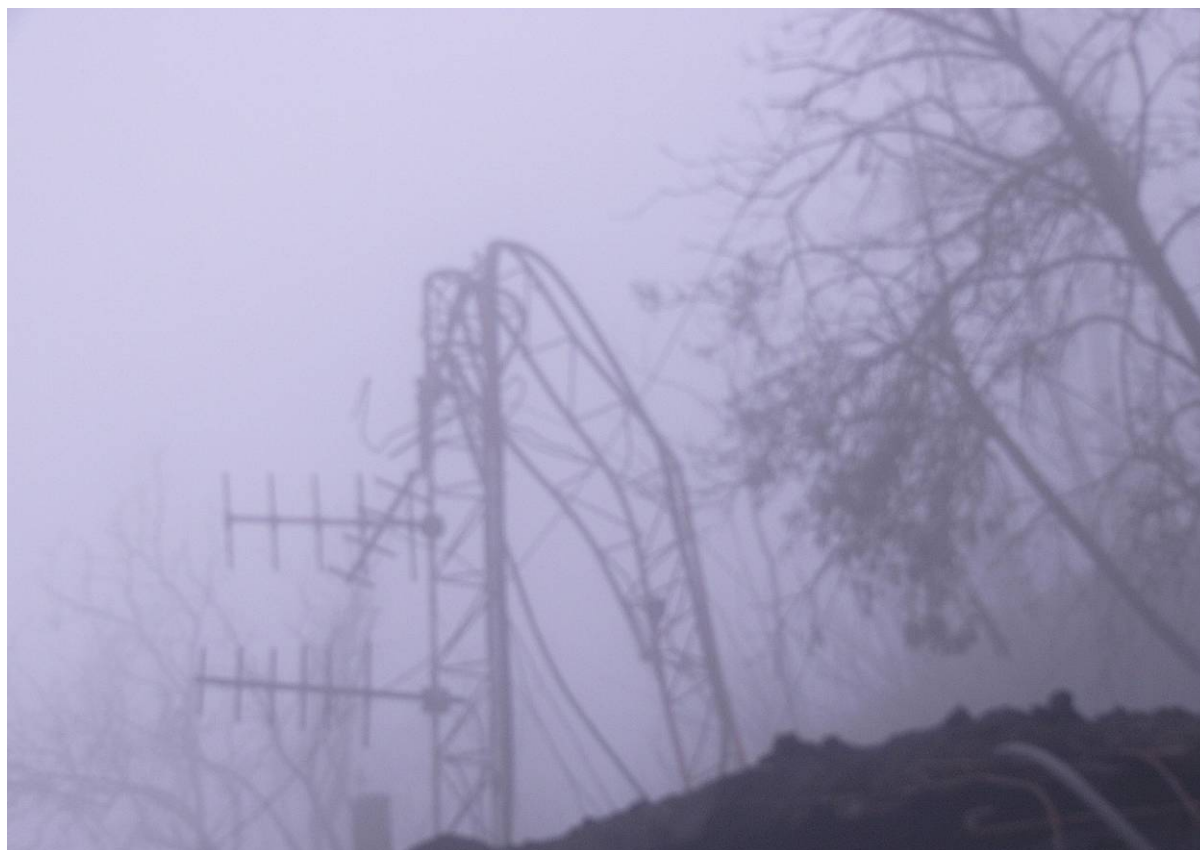
**Figure 3.19** A radio communications tower on Cerro Chino that buckled from ballistic and block impacts (photo: Gustavo Chigna, INSIVUMEH).

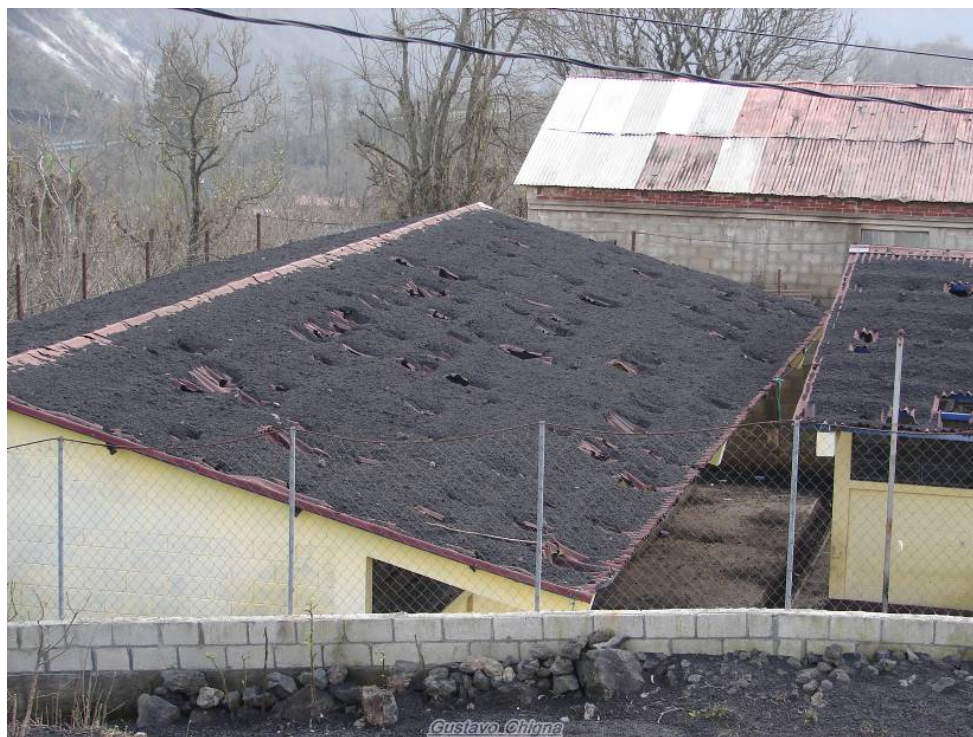
**Figure 4.3** Ballistic damage to roof, San Francisco de Sales (located approximately 3 km north of the vent). Ballistics in this area reached 25 cm in diameter (long axis) (photo: Gustavo Chigna, INSIVUMEH).

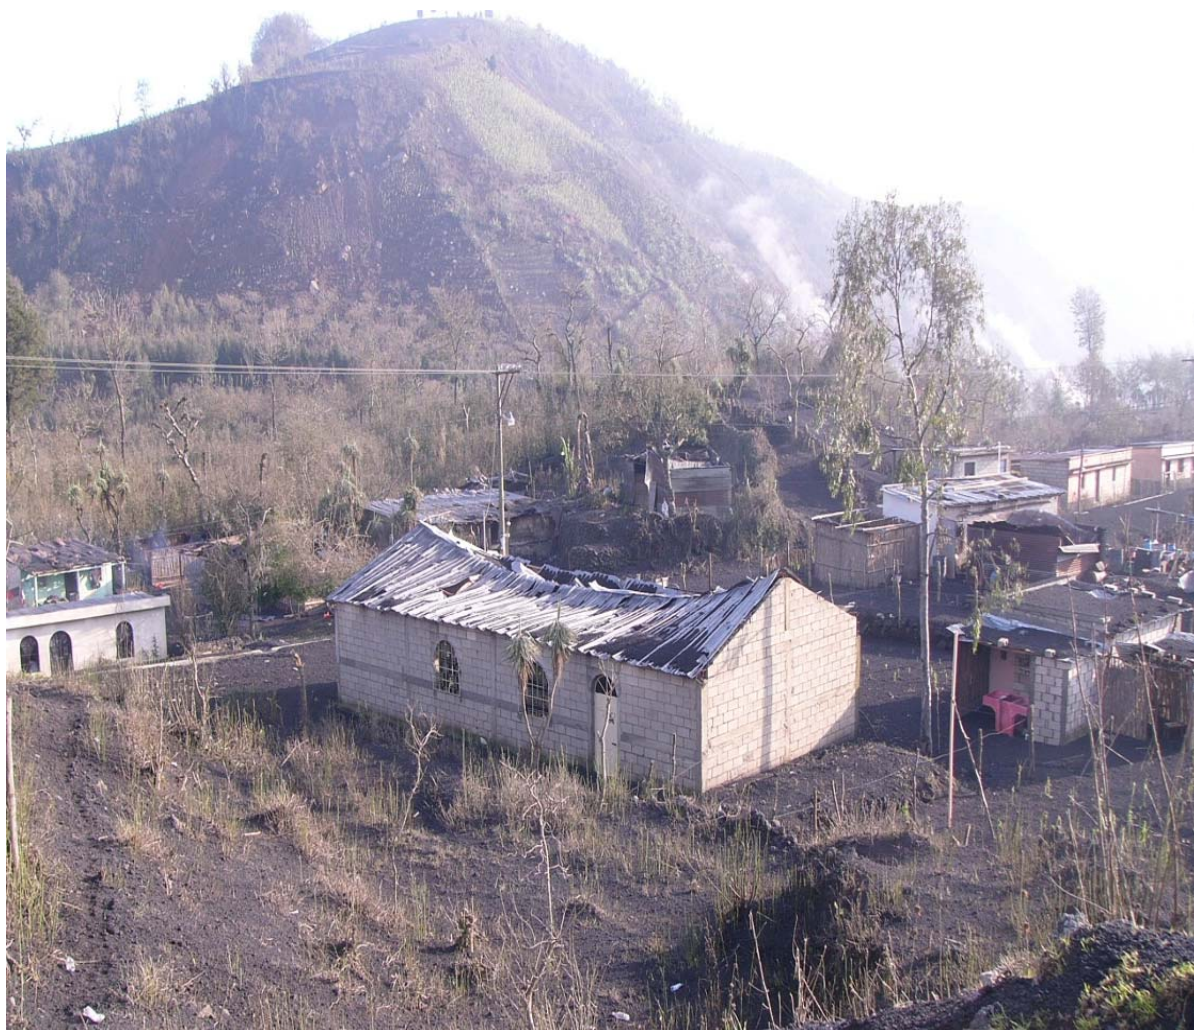
**Figure 4.4** Roof collapse due to tephra loading, San Francisco de Sales (photo: Gustavo Chigna, INSIVUMEH).

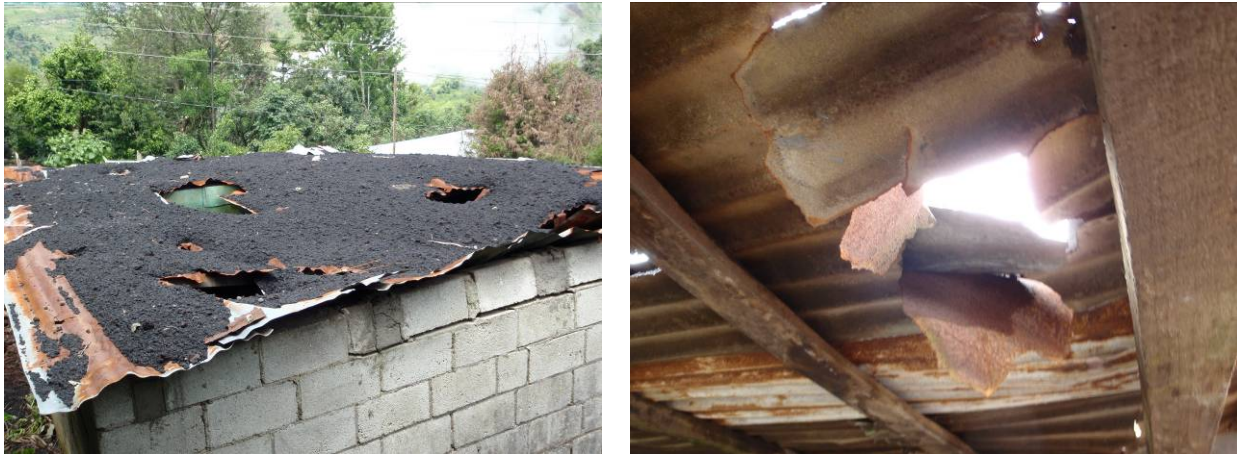
**Figure 4.6** Tephra deposition and ballistic damage to roofs, San Francisco de Sales, 19 September 2010.
